# Locating Discontinuous LNAPL Contamination

## GeoTrax Survey™ Case Study

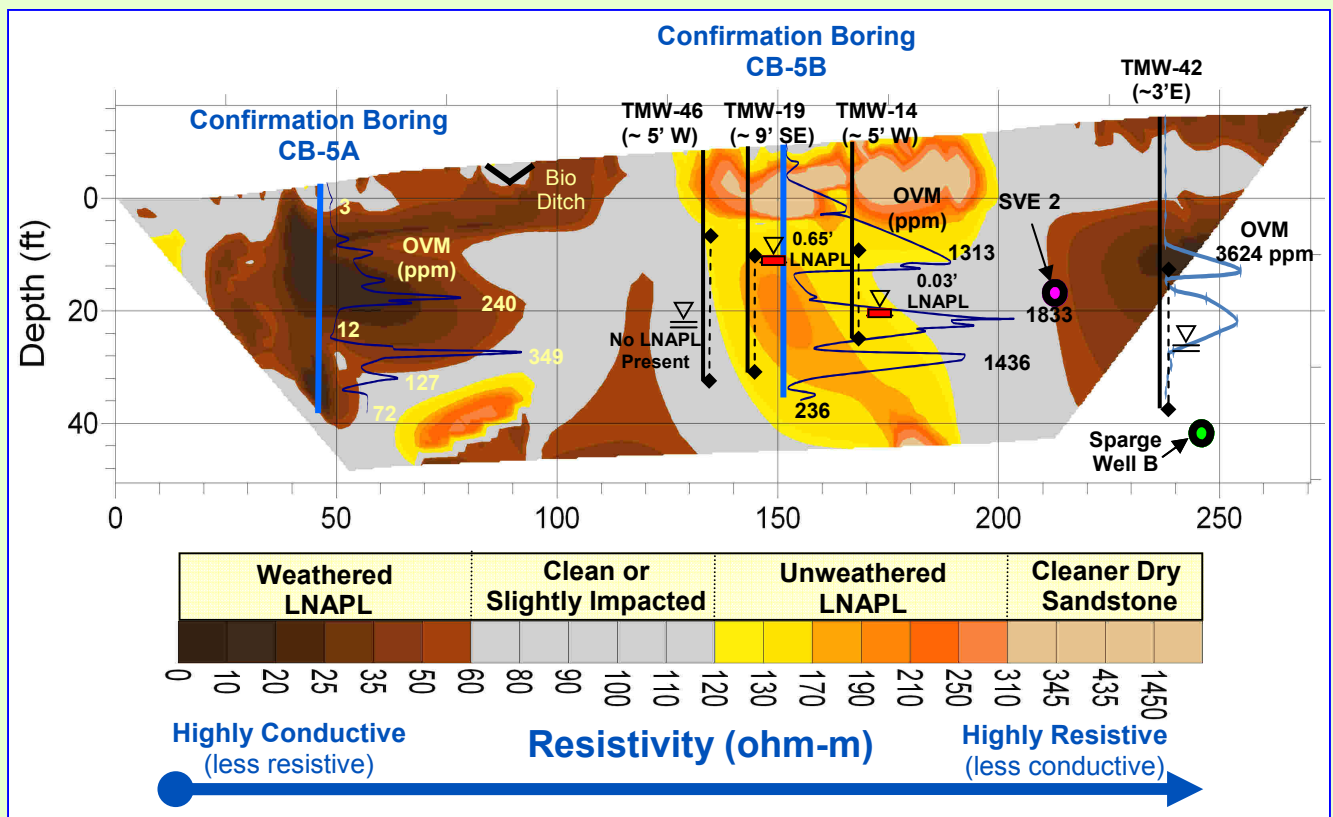
- Vertically oriented anomalies confirmed to be LNAPL and related dissolved phase contamination; these vertical features would be hard to detect/bound using wells alone (without a high resolution scanning tool like GeoTrax Survey™).

- The brown conductive anomalous area on the right of the image strengthened our clients' theory that contamination was moving on-site from an off-site source.

- The resistive orange and yellow areas in the central part of the image below the water table were confirmed to be LNAPL and dissolved phase contamination, respectively.

- The beige area above the water table and near the ground surface is harder sandstone with slight PID readings. It's possible that the effects of soil vapor are seen on this image.

- The brown conductive anomaly to the left of the image was confirmed to be a wet sandy area that is somewhat impacted by LNAPL related contamination.
