Bottom Line:

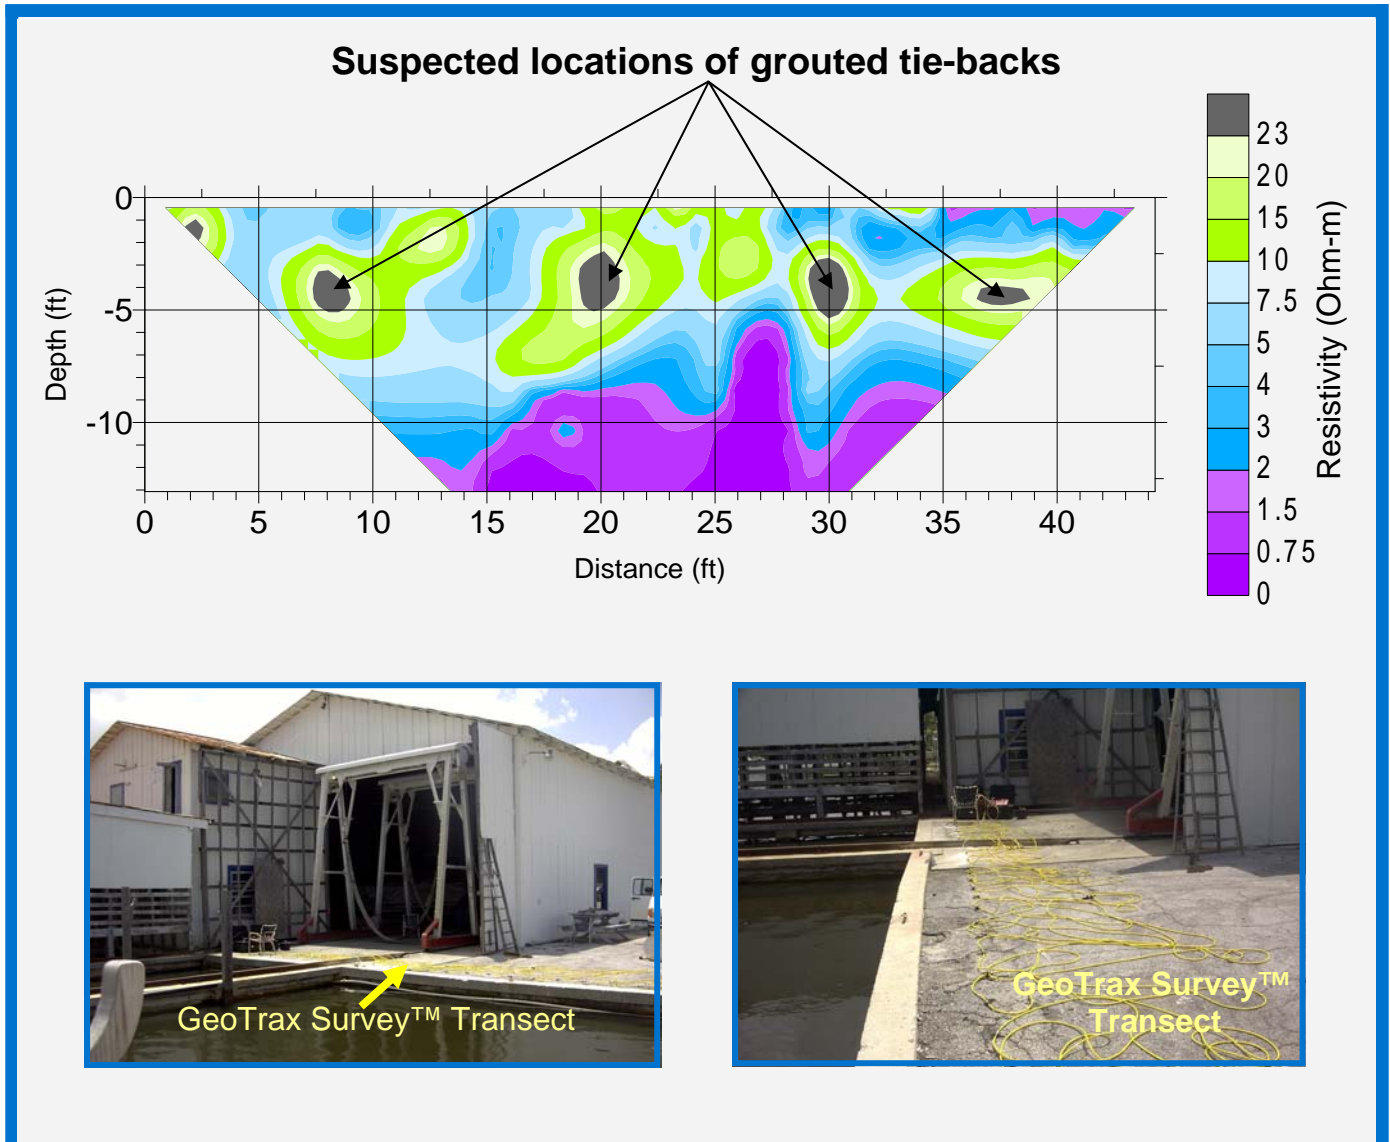
- Aestus was retained to image the construction of the coastal bulkhead at the above pictured site in Florida, prior to planned renovation of the marina.
- Evenly spaced anomalies were detected at consistent depth; suspected to represent the location of grouted tiebacks.
- Grouted tiebacks are typically constructed as steel rods drilled through a concrete wall and into the soil on the other side. Grout is then pumped under pressure into the tieback anchor holes such that the rods can utilize soil resistance to prevent tieback pullout and subsequent wall destabilization. The presence of the grout can cause relatively electrically resistive anomalies to appear in Aestus' subsurface images.
