Locating DNAPLs in Hard Rock at Former MGP Site

GeoTrax Survey™ Case Study (Page 1 of 3)

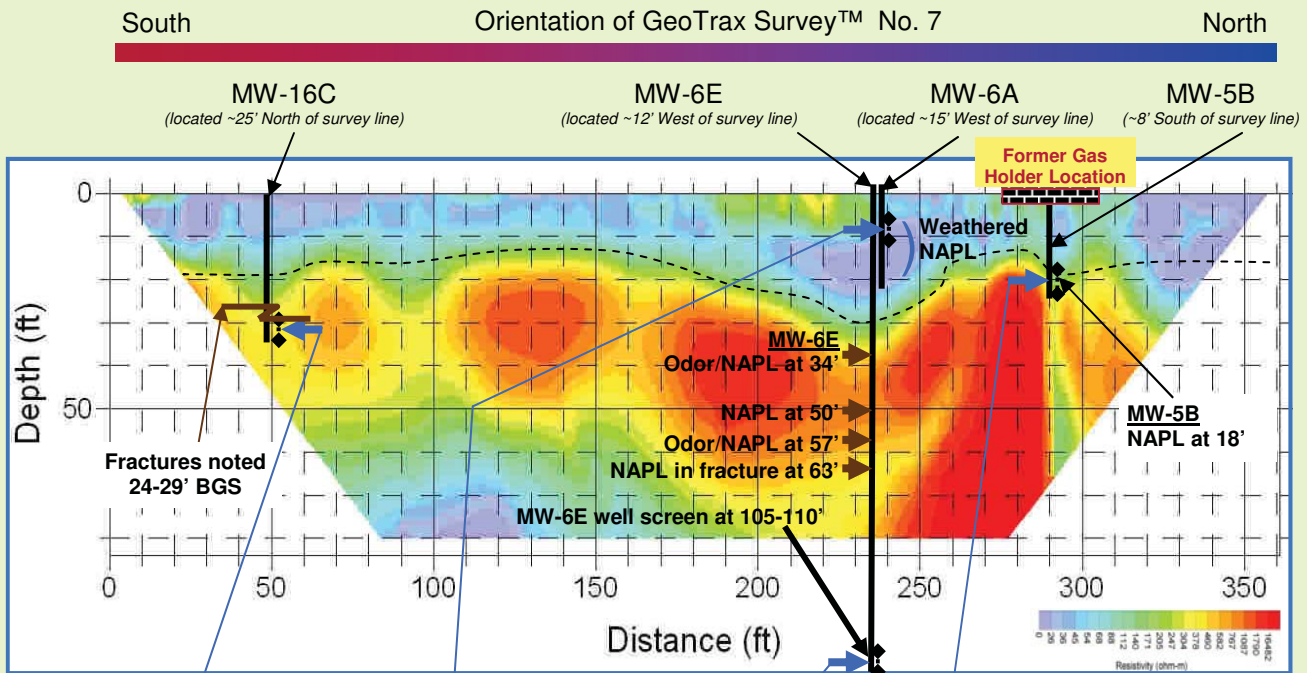
MW-16C	
Sample Date	9/06
Units	µg/L
Benzene	180
Toluene	<40
Ethylbenzene	470
Xylene	320
Total PAH	3,688
Benzo(a)Pyrene	12

MW-6A	
VOCs in Groundwater (ug/L)	
Sample Date	9/1/2004
MTBE	<20
Benzene	3,500
Toluene	1,400
Ethylbenzene	3400
Total Xylenes	4900
1,2 - Dichloroethane	62
Total Naphthalene	5600

MW-6E	
VOCs in Groundwater (ug/L)	
Sample Date	9/1/2004
MTBE	<0.30
Benzene	0.45
Toluene	<0.40
Ethylbenzene	<0.30
Total Xylenes	<0.70
1,2 - Dichloroethane	<0.40
Total Naphthalene	0.73

MW-5B	
VOCs in Groundwater (ug/L)	
Sample Date	11/11/2003
MTBE	<20
Benzene	31,000
Toluene	11,000
Ethylbenzene	3300
Total Xylenes	3600
1,2 - Dichloroethane	<15
Total Naphthalene	8900

- Survey image generally shows difference in alluvial geology in upper ~20 feet with more conductive silts/clays (light blue zones) versus underlying fractured dolomite rock with higher resistivities (green-yellow zones)

- Image shows anomalous zones especially below the former gas holder location where a strong vertical resistive signature indicates likely presence of DNAPL contamination (red zones); DNAPL confirmed at this location by borehole for monitoring well MW-5B

- DNAPL contamination confirmed in borehole for MW-6E in zones coincident with higher resistivity (i.e., red/orange zones)
- Image implies that resistive zones extend below the bottom of the image; Monitoring well MW-6E confirms presence of groundwater contamination at 105-110 feet BGS.

- Highly conductive anomaly coincident with noted presence of weathered NAPL in alluvium soil boring (purple zone at borehole for monitoring well MW-6A)

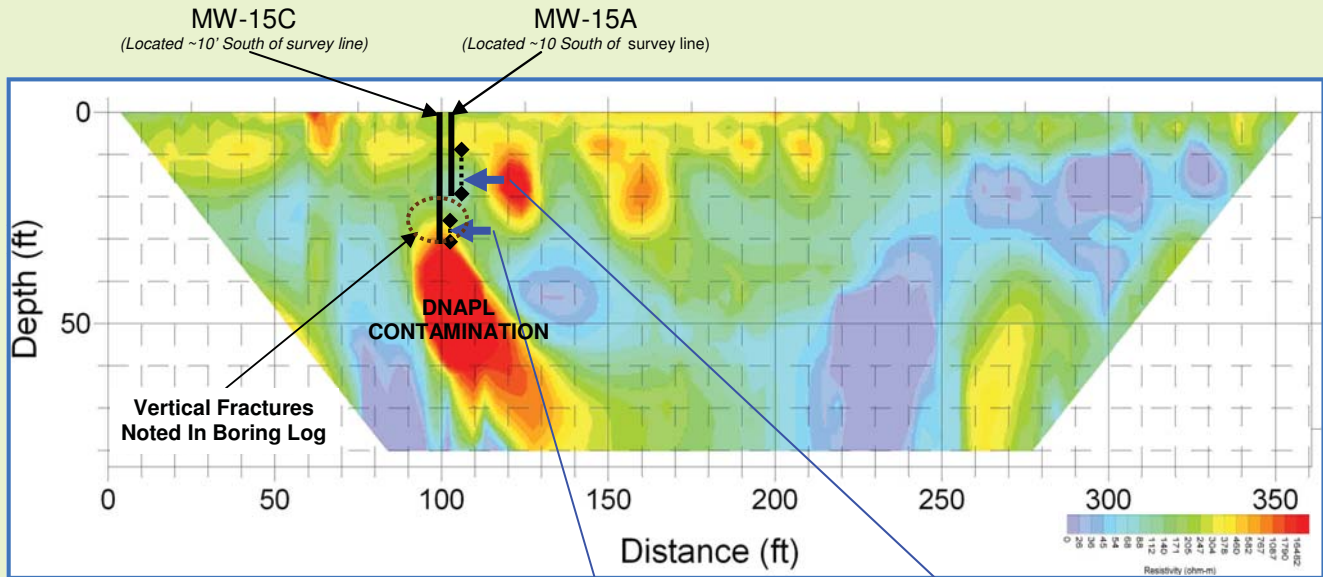
West Orientation of GeoTrax Survey™ No. 4A East

MW-15C		MW-15A	
Sample Date	9/06	Sample Date	9/06
Units	µg/L	Units	µg/L
Benzene	190	Benzene	<0.40
Toluene	<4.0	Toluene	<0.40
Ethylbenzene	73	Ethylbenzene	<0.50
Xylene	34	Xylene	<1.5
Total PAH	555	Total PAH	0
Benzo(a)Pyrene	4.9	Benzo(a)Pyrene	<0.019

- DNAPL contamination was confirmed anomalous zone (highly resistive red blob-shaped anomaly) via drilling (Monitoring Well 15C)
- Clean zone (anomaly free) above this contamination was confirmed via drilling (Monitoring Well 15A)
- Image implies that other relatively small pockets of contamination may exist as shown by presence of more resistive anomalous zones
- Other anomalous zones exist (both resistive and conductive anomalies) that likely represent discrete pockets in shallow alluvium and deeper bedrock zones.
