Case Study

Leachate Excursion at Karst Landfill

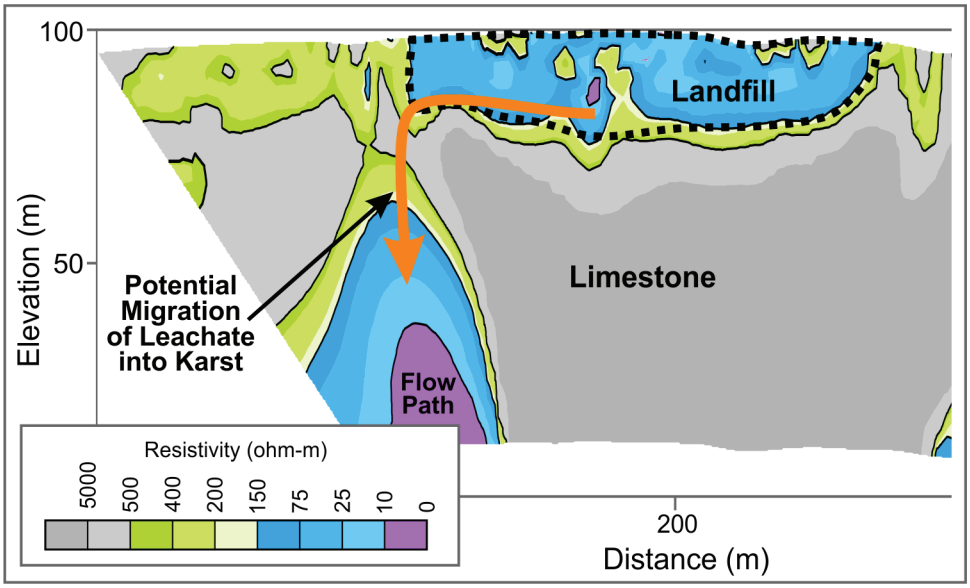
Aestus' GeoTrax Survey™ scanning technology was used to delineate the landfill boundaries as well as the geologic conditions beneath the landfill to a depth of about 100 meters. The graphic above shows:

- Landfill extents with underlying competent limestone
- Karst void/cave likely containing leachate impacted groundwater
