# CASE STUDY
DRY CLEANER SITE (SOLVENTS/BIO)

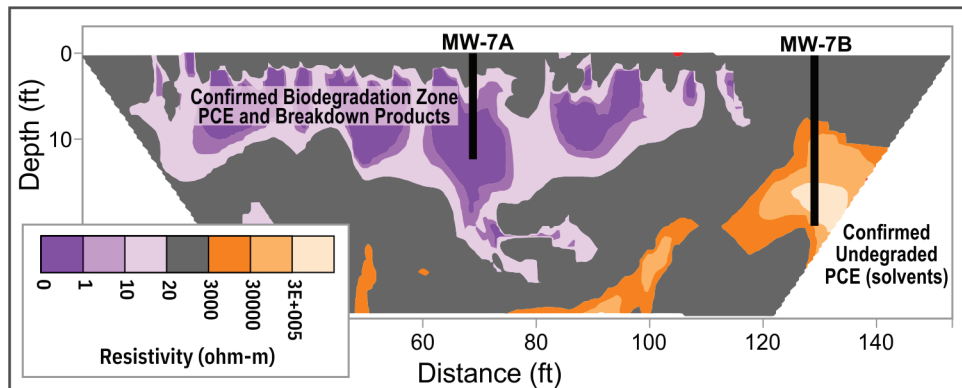
Aestus integrated historical and targeted confirmation drilling data onto our GeoTrax Survey™ 2D subsurface images as well as our 3D visualization model. Drilling and sampling data were used to determine how varying electrical resistivity levels correlated to contaminants, geology, and bioactivity.

Purple zones show where injection work effectively stimulated biodegradation. Updated CSM shows undegraded/untreated PCE in orange zones requiring additional remediation.
