ERI Evaluation of Injectates Used at a Dry-Cleaning Site

A former dry-cleaning site in Jackson, Tennessee, has undergone remediation to treat dense nonaqueous-phase liquid (trichloroethene [TCE] and tetrachloroethene [PCE]) contamination in the subsurface. The dry cleaning operation closed in 1977. In 2002, a series of injections were made at the site consisting of corn syrup, vegetable oils, and Simple Green®. In 2004, approximately 200 cubic yards of contaminated soil were excavated, and the bottom of the excavation was covered with sodium lactate.

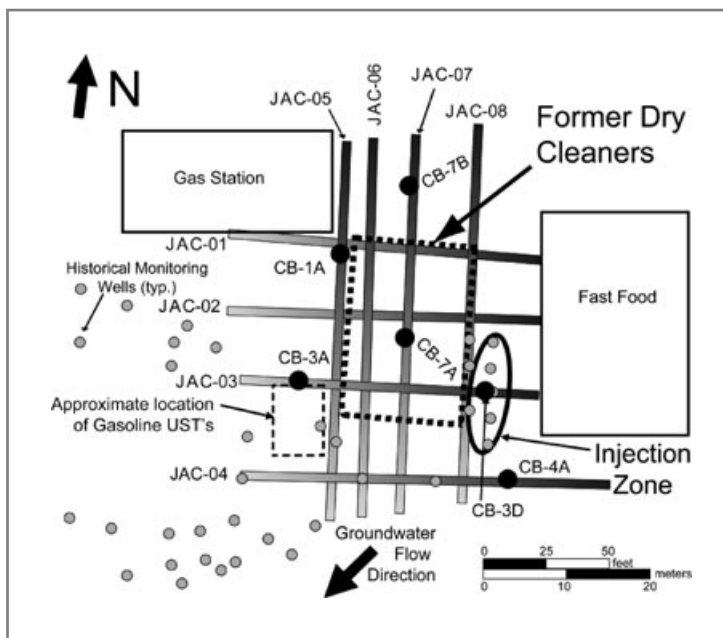
Exhibit 1. Map of former dry-cleaning site in Jackson, Tennessee

Location of former dry cleaners illustrated with dashed rectangle. Wells used as part of an injection scheme in 2002 illustrated with a solid oval. Location of eight ERI lines used to evaluate the site shown as heavy lines.

The project site is a former dry-cleaning site, Boone Dry Cleaners, located in Jackson, Tennessee (Exhibit 1). The site operated as a dry cleaner between the mid-1940s and the mid-1970s, at which time it was converted to a welding facility. In 2003, a tornado destroyed the structure, and the site became a parking lot for a convenience store that is currently an operating retail gas station using underground storage tanks.

Eight ERI were collected using the Halihan/Fenstemaker method (Halihan & Fenstemaker, 2004), which is available commercially as Aestus, LLC's GeoTrax Survey™ technology. The ERI activities were performed during night-shift work to minimize interference to daytime business and traffic flow at the adjacent convenience store/gas station (Exhibits 1 and 2).

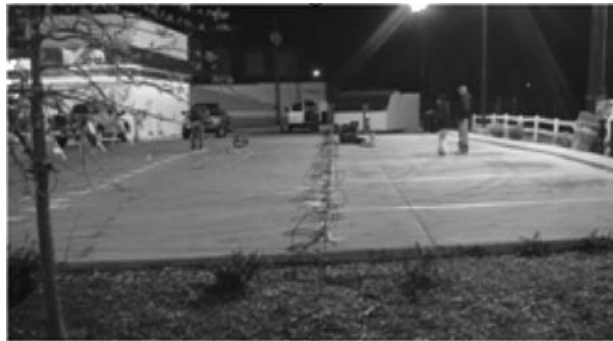
Exhibit 2. Photograph of the deployment of ERI lines at former dry cleaners in Jackson, Tennessee

Work was conducted at night to avoid interfering with the adjacent businesses during the day. 56 electrode array being collected in centerline of image. Preparation for the next line is occurring to the left.

Transect lines were surveyed and marked in the field, then electrode stakes were installed in the ground at specified, uniform intervals. The surveys were conducted using 56 electrodes at spacings ranging from 0.65 to 0.85 meters, yielding total line lengths ranging from 35.75 to 46.75 meters (117 to 153 feet). This layout facilitated data collection from the ground surface to depths of 7 to 9 meters (23 to 31 feet) bgs.

In grassy areas, electrodes were installed with a hand sledgehammer. In areas covered with asphalt and/or concrete, a rotary hammer drill was used to drill a 1/2-inch diameter hole, which allowed electrodes to be installed and contact material below the concrete. Once installed, electrical contact resistance was checked to ensure that the electrode stakes had good electrical contact with the ground. In some areas, the concrete cap was too thick to fully penetrate with rotary hammers, and the electrodes were installed in the drill holes that allowed the contact resistance to drop to an acceptable level for imaging through the concrete mass to soils below.

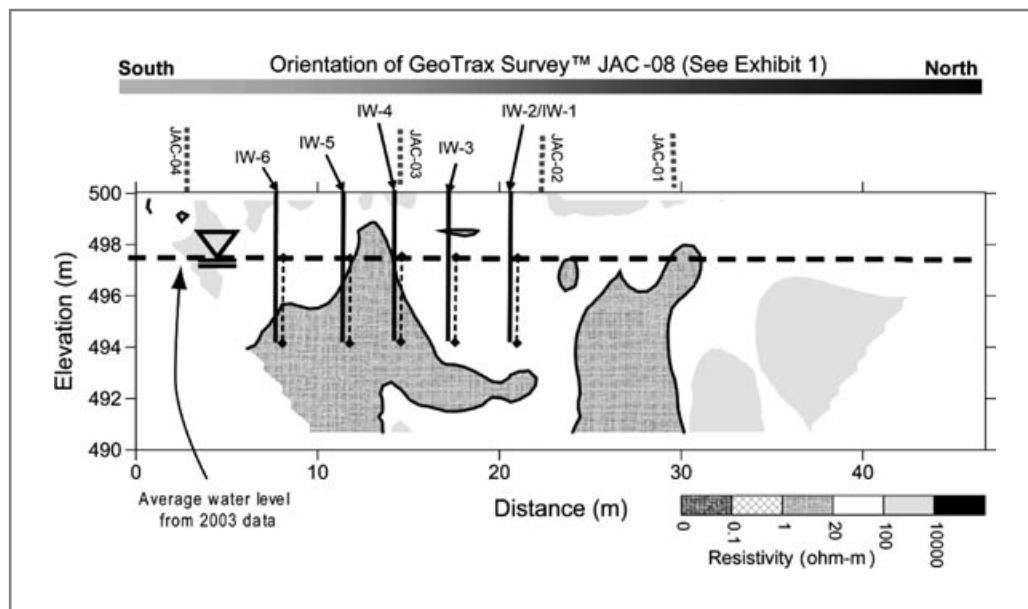
Exhibit 3. Electrical resistivity image of survey JAC-08

ERI cross-section (pseudosection) is illustrated with the location of injection wells, the average water-table elevation, and the location of cross lines. The profile on the right side of the image at approximately 40 meters horizontal distance illustrates the interpreted background electrical properties of the site. The lower resistivity (more conductive) 1 to 20 ohm-meter regions to the left are interpreted to be related to the injection process.

The proprietary ERI data demonstrate a wide range of resistivity values in the inverted model resistivity data. In the area where the injections took place, values range from approximately 3 to 1,200 ohm-meters (Exhibit 3, Survey JAC-08). The data show dominantly vertical trends near the injection wells instead of the expected horizontal trends that would be generated by the native geology, which is horizontally bedded. The sandy interval below 3 meters (10 feet) is greater than 100 ohm-meters in the area north from the injection wells (gray colors on right side in Exhibit 3) but is more conductive (less than 20 ohm-meters) in the area where the injections occurred (stippled area on the left side in Exhibit 3). The increase in conductivity generally occurs beneath the water table in the injection zone.

some areas. The highly conductive area tends to be broken into five to six separate pieces (dotted areas on Exhibit 4) that roughly correspond to the number of injection wells (screened intervals shown on Exhibit 3).

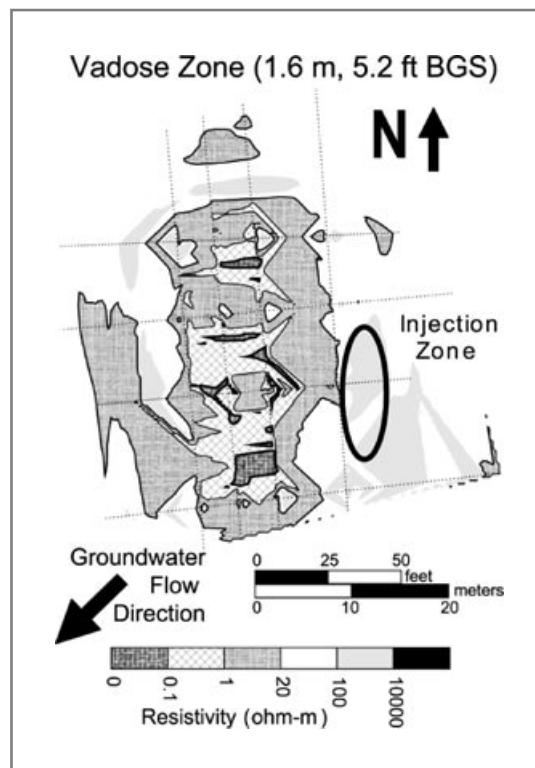
Exhibit 5. Interpolated horizontal depth slice of ERI data interpolated from GeoTrax Surveys™ at 1.6 meters (5.2 feet) below ground surface

The location of the injection zone is illustrated with a dark oval, but the injection occurred below the elevation of this depth slice. The resistivities associated with the center of the image are below 1.0 ohm-meter, which is extremely conductive for a freshwater environment. Additionally, the region exists with little relationship to the regional groundwater flow direction.

The horizontal depth slice in the vadose zone (1.6 meters bgs, 5.2 feet) illustrates the location of the interpreted microbial bloom in the vadose zone. The injectate plume appears to have spread more in the north/south direction than the east/west direction with a portion located upgradient from the injection zone. Small, highly resistive blob-shaped anomalous zones are visible near the edges of the conductive plume (Exhibit 5). This conductive area is connected to the injection-well location, but the values are most conductive downgradient of the injection wells.

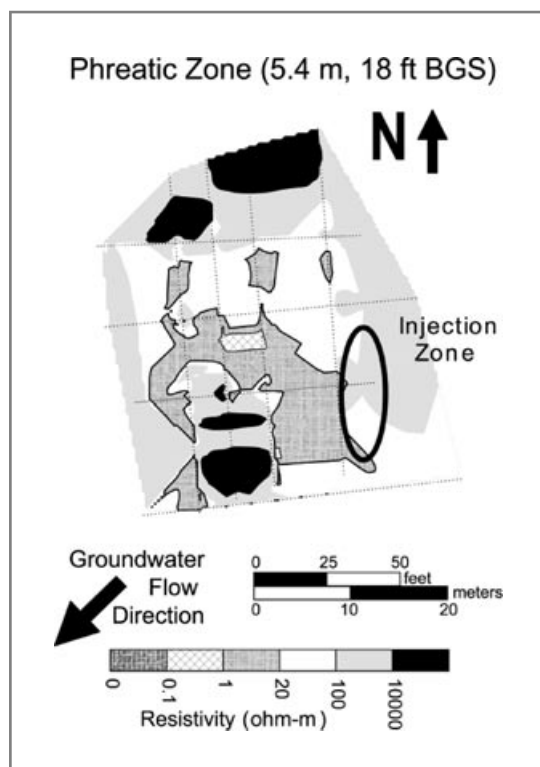
Exhibit 6. Interpolated horizontal depth slice of data taken from GeoTrax Surveys™ at 5.4 meters (18 feet) below ground surface

The location of the injection zone is illustrated with a dark oval and injected into the horizon associated with this depth slice. The resistivities associated with the center of the image are below 20 ohm-meters, which is interpreted as a signature of the injectate path. This region has little relationship to the regional groundwater flow direction. The large black resistivity body down the regional hydraulic gradient has been correlated to undegraded TCE and PCE that was not affected by the injection program.

The horizontal depth slice in the phreatic zone (5.4 meters bgs, 18 feet) occurs below the water table (Exhibit 6). This depth slice illustrates the higher volume of highly

resistive anomalies in the subsurface at the edges of the survey area, with some conductive areas to the west and northwest of the injection wells. These data indicate that DNAPL may have existed beyond the survey area prior to injection, or that the injection activities may have pushed DNAPL out to the survey boundaries.

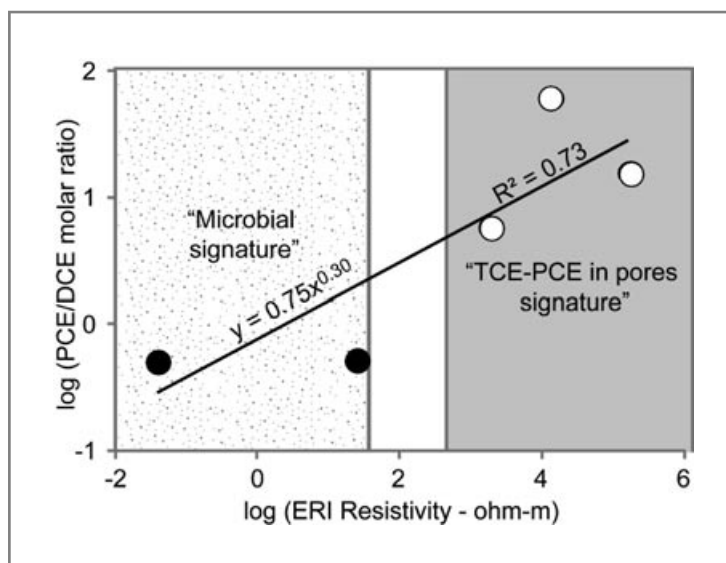
Exhibit 8. Graph of ERI resistivity values against PCE/DCE molar ratios

While the data provide a statistically significant trend, the cause of the signature is interpreted as being generated by two different mechanisms. Low PCE/DCE molar ratios (less than unity or a log value of zero) generate a low resistivity signature due to microbial processes, while high PCE/DCE molar ratios generate a high resistivity due to higher DNAPL saturations in the pore space.

A plot of the PCE/DCE molar ratio from groundwater analytical data (from confirmation borings) against resistivity of the confirmation boring midscreen interval shows that lower ratios correspond well to more conductive areas (0.01 to 1.0 ohm-m), while higher ratios correspond to more resistive areas (100 to 1,000,000 ohm-m; Exhibit 8). These results are expected, because as biological activity increases, conductivity and degradation products such as DCE increase (as DCE amounts increase in relation to PCE, the ratio becomes smaller). Areas with less degradation tend to stay

more resistive, which is reflected in the higher PCE/DCE ratio. A power law function fits the data with a goodness of fit of 0.73 (Exhibit 8).
