# Evaluating DNAPL Recovery System Performance

## GeoTrax Survey™ Case Study

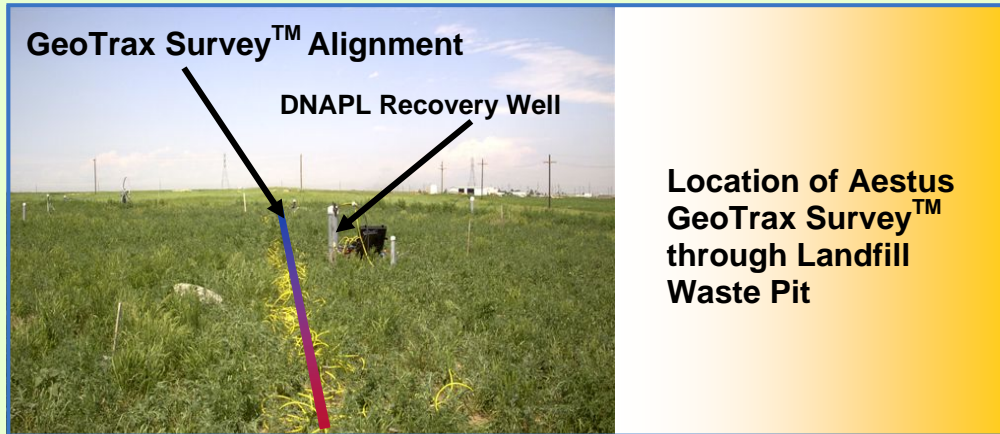
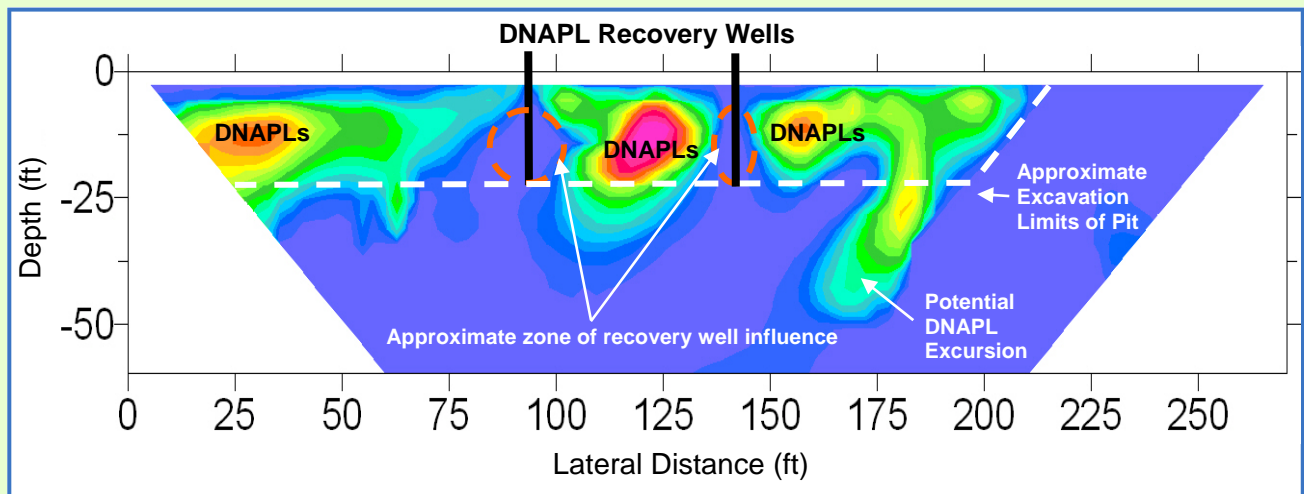
Aestus performed our GeoTrax Surveys™ to assess the performance of a DNAPL recovery system installed within a waste pit at a hazardous waste landfill. The two remediation wells along our survey transect had been “clean” for two years prior to our confirmation survey work. The GeoTrax Survey™ results indicated that recovery wells have achieved significant reduction of DNAPLs near the source areas and within the wells’ actual zone of influence which was significantly smaller than the design zone of influence which was one-half of the well spacing.

However, Aestus also demonstrated that large sources of DNAPLs are still present, and a potential vertical DNAPL excursion was noted at the east side of the waste pit. In addition, the excavation limits of the eastern edge of the waste pit are clearly visible. This information will be useful in allowing our client to focus supplemental remediation efforts.
