## **ERI EVALUATION OF INJECTATES USED TO REMEDIATE A DRY CLEANING SITE, JACKSON, TENNESSEE**

*Todd Halihan, Oklahoma State University, Stillwater, OK*

### **Abstract**

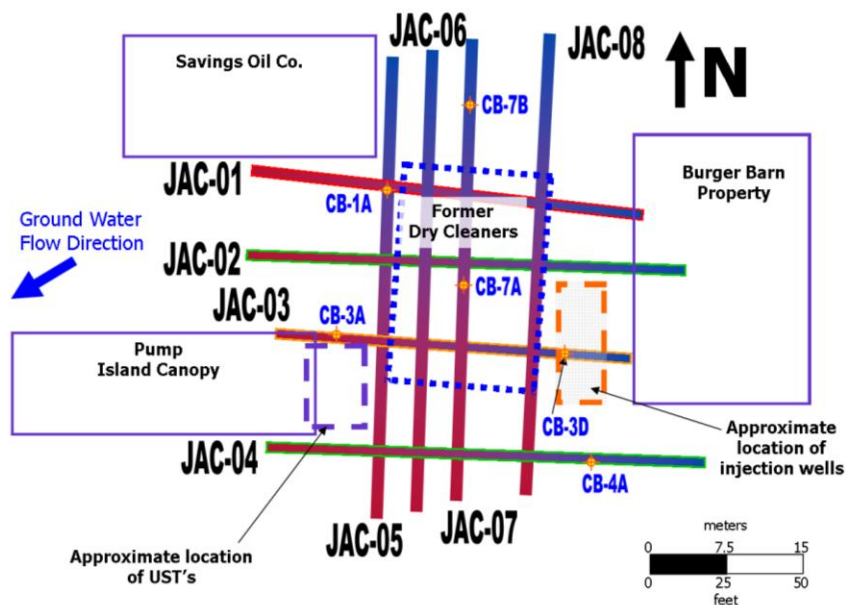
**Figure 1:** Site map of former Boone Dry Cleaner site in Jackson, TN. Locations of ERI lines are shown in heavy red/blue lines with JAC-0X labels. Locations of confirmation borings shown with blue labels.

The project site is a former dry cleaning site, Boone Dry Cleaners, located in Jackson, Tennessee (Figure 1). The site operated as a dry cleaner between the mid-1940's and the mid-1970's, at which time it was converted to a welding facility. In 2003 a tornado destroyed the structure and the site became a parking lot for a convenience store that also is an operating retail gas station using underground storage tanks. Subsequently the site was capped with a thick layer of concrete in some areas (approximately 2-3 feet).

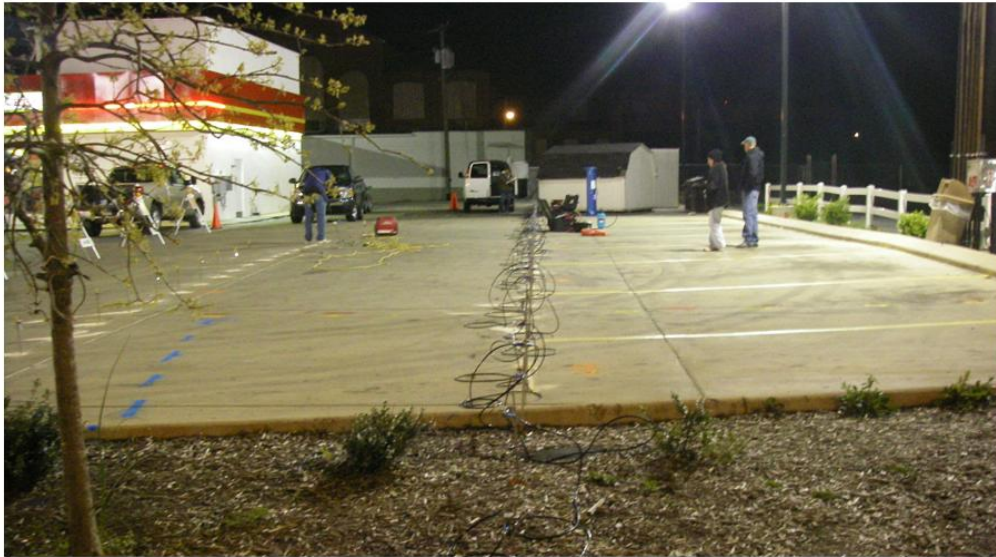
**Figure 3:** View of ERI line JAC-07 looking north at the former Boone Dry Cleaning facility in Jackson, TN. Data were collected at night to minimize disruptions to businesses currently located on the site.

Eight high resolution electrical resistivity images (ERI) were collected using the Halihan/Fenstermaker method (available commercially as Aestus, LLC's GeoTrax Survey™ technology; Halihan and Fenstermaker, 2004). The data were collected during night shift work to allow the convenience store/gas station to continue operating during the ERI data collection activities (Figures 1 and 3). Surveys were first laid out using a measuring tape, and then electrode stakes were installed in the ground at specified intervals. Electrodes were installed with a hand sledge hammer in grassy areas. In areas covered with asphalt and/or concrete, a hammer drill was used to drill a 3/8-inch hole, which allowed electrodes to be installed and contact material below the concrete. Once installed, contact resistance was checked to ensure good electrical contact with the ground. In some areas the concrete cap was too thick to fully penetrate with rotary hammers and the electrodes were installed in the drillholes that allowed the contact resistance to drop to an acceptable level for imaging. The surveys were conducted using 56 electrodes at spacings ranging from 0.65-0.85 meters yielding total line lengths ranging from 35.75-46.75 meters (117-153 feet). This facilitated data collection from the ground surface to depths of 7-9 meters (23-31 feet).
