Locating LNAPL Migration From Upgradient Property GeoTrax Survey™ Case Study

Retail Station Assessment - Ada, Oklahoma

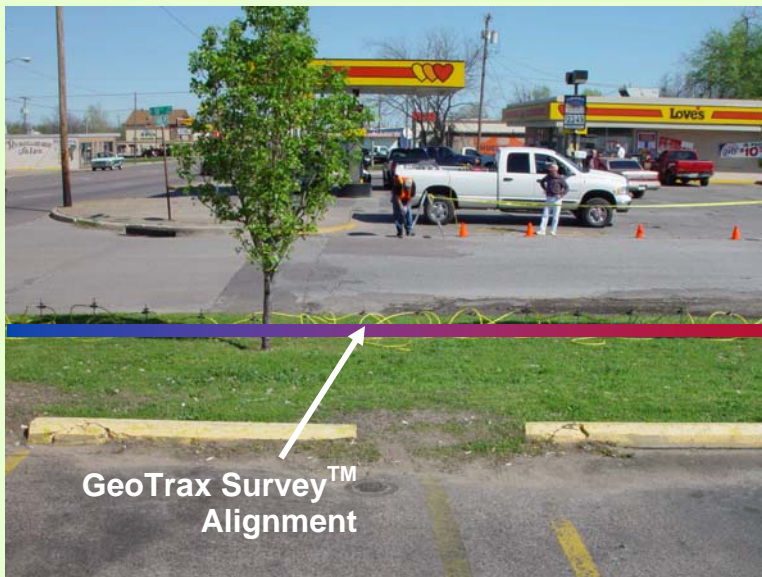
Location of Aestus
GeoTrax Survey™
Upgradient of Nearby
Retail Gas Station

The State of Oklahoma asked Aestus personnel to survey the boundaries between two retail gas station sites. The retail site in the photo above had already undergone cleanup and was declared clean. However, an upgradient monitoring well encountered LNAPLs during routine monitoring.

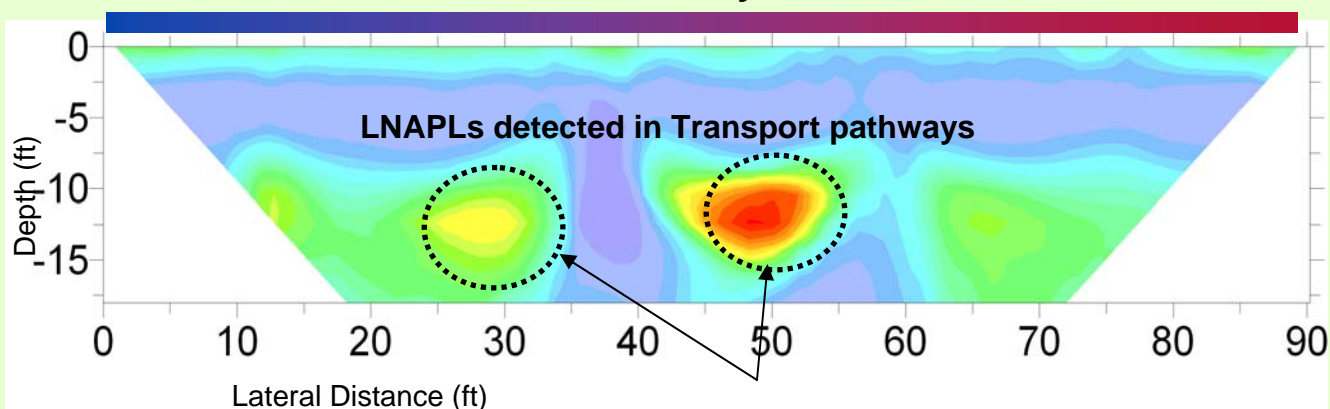
GeoTrax Survey™ Results

Aestus conducted a survey orthogonal to groundwater flow to identify the presence or absence of LNAPLs. Two significant anomalies were identified and the State of Oklahoma subsequently drilled and confirmed the presence of LNAPL/dissolved phase concentrations in these pathways.
