CASE STUDY

PAH/NAPL IN BEDROCK AT MGP SITE

Project Overview:

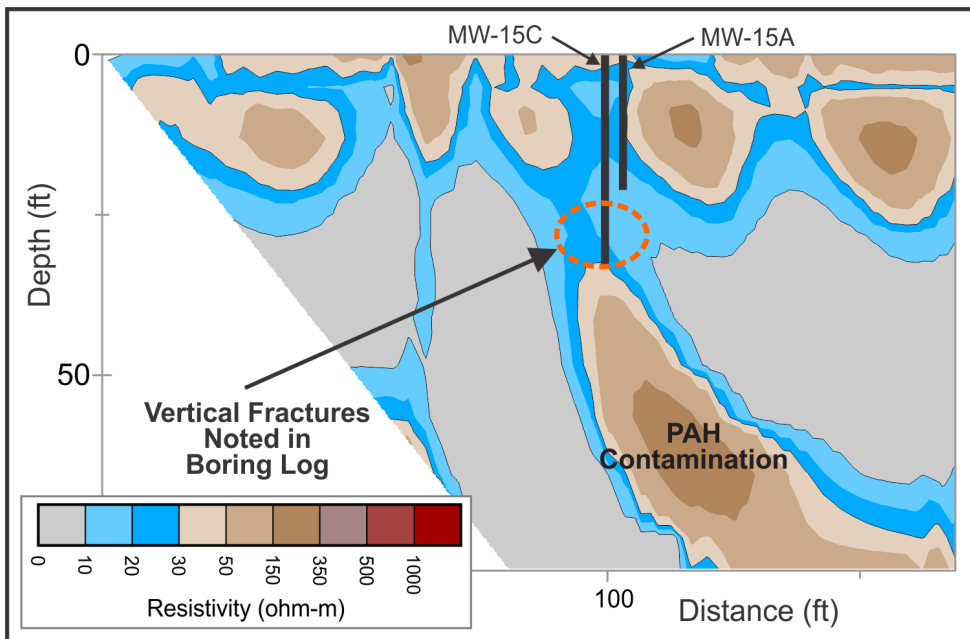
Targeted Confirmation Sampling Confirmed Downgradient Pathways:

- Less weathered PAH contamination was confirmed anomalous zone (resistive brown blob-shaped anomaly) via drilling (MW 15C)
- Clean zone (normal resistivity) above this contamination was confirmed via drilling (MW15A)
- Other anomalous zones exist in site data (both resistive and conductive anomalies) that likely represent discrete pockets in shallow alluvium and deeper bedrock zones.

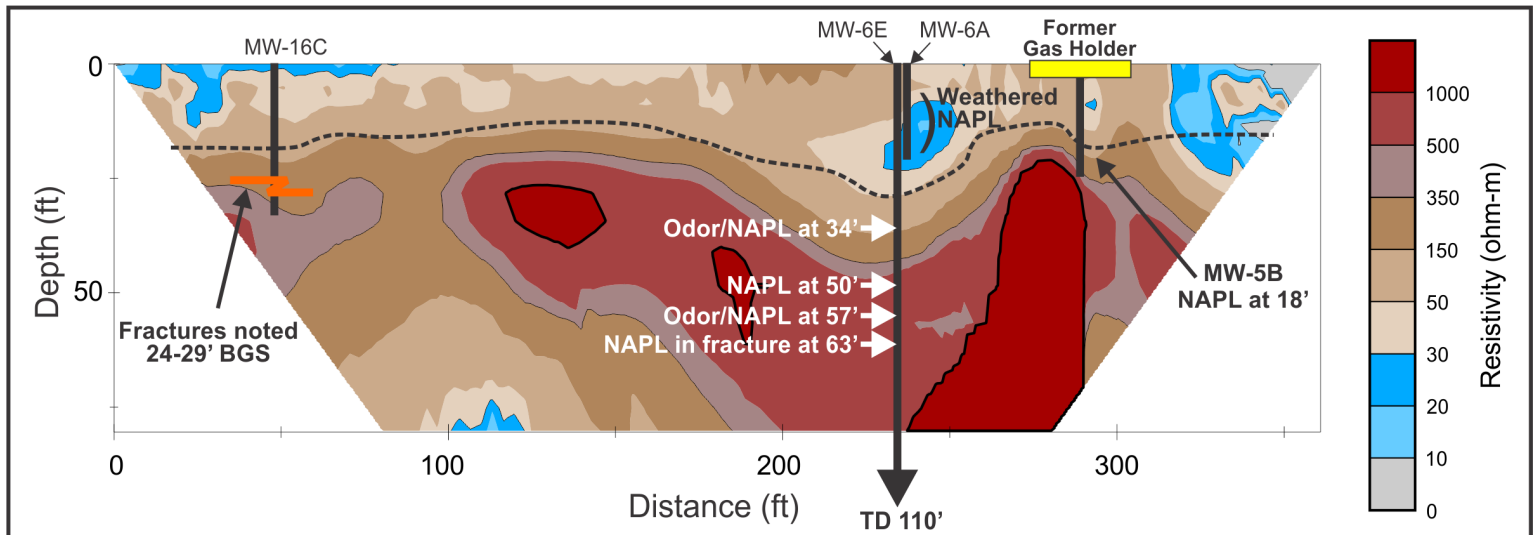
Vertical Migration of DNAPL Near Former Gas Holder Source Also Confirmed:

- GeoTrax Survey™ image generally shows difference in alluvial geology in upper ~20 feet with more electrically conductive silts/clays (blue and light brown zones) versus underlying fractured dolomite rock with higher resistivity's (dark brown zones)
- Image shows highest resistivity below the former gas holder location indicating likely presence of unweathered PAH/NAPL impacts (burgundy zones); PAH/NAPL confirmed at MW-5B
- PAH/NAPL contamination confirmed in borehole for MW-6E in zones coincident with higher resistivity (burgundy zones)
- Highly conductive anomaly (blue zone) is coincident with presence of weathered PAH/NAPL in alluvium soil boring during installation of monitoring well MW-6A
- Image implies that resistive zones extend below the bottom of the image and deeper PAH/NAPL impacts were confirmed via drilling
